The Plight of an Urban Stream

A Walk Along Little Falls Branch Creek

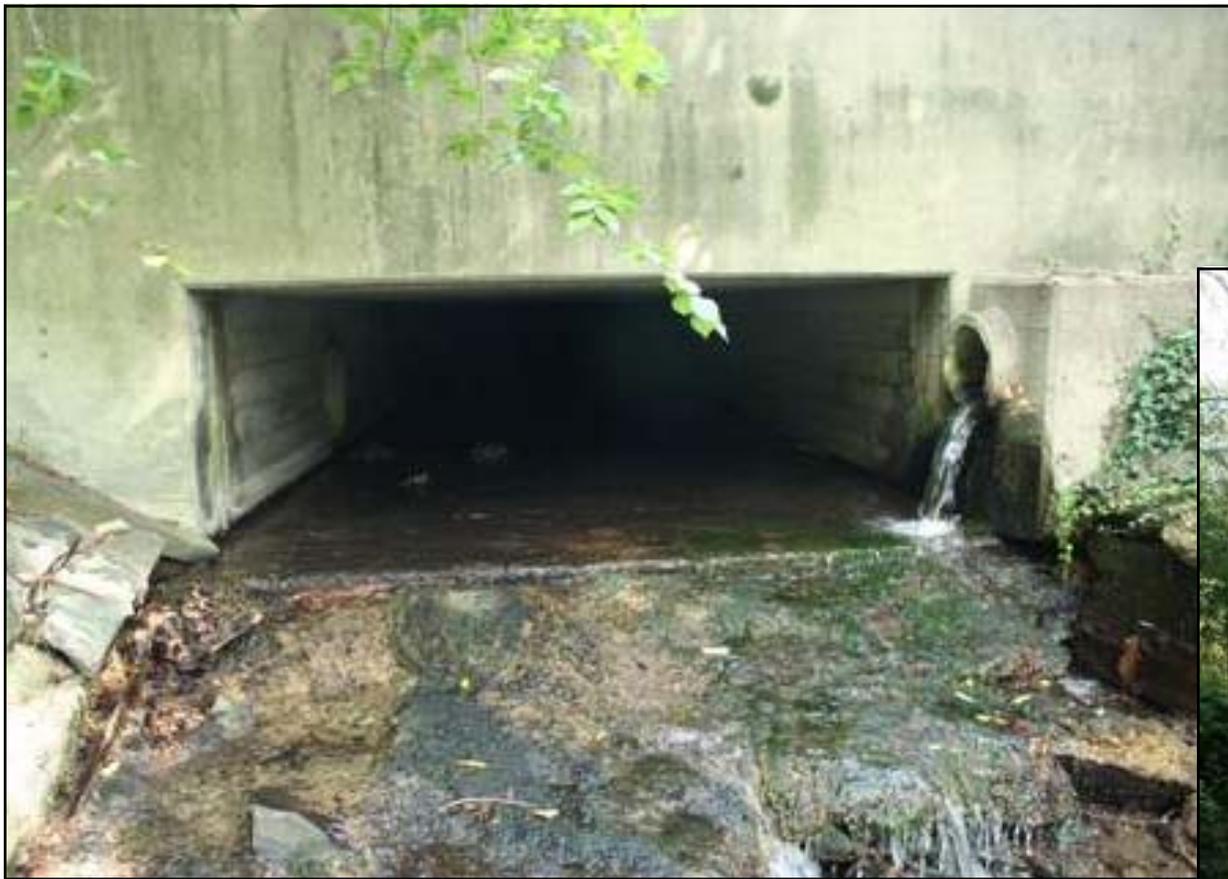
Little Falls Branch at Wisconsin Avenue. The inlet pipe on the right carries ground water pumped from Metro tunnels.

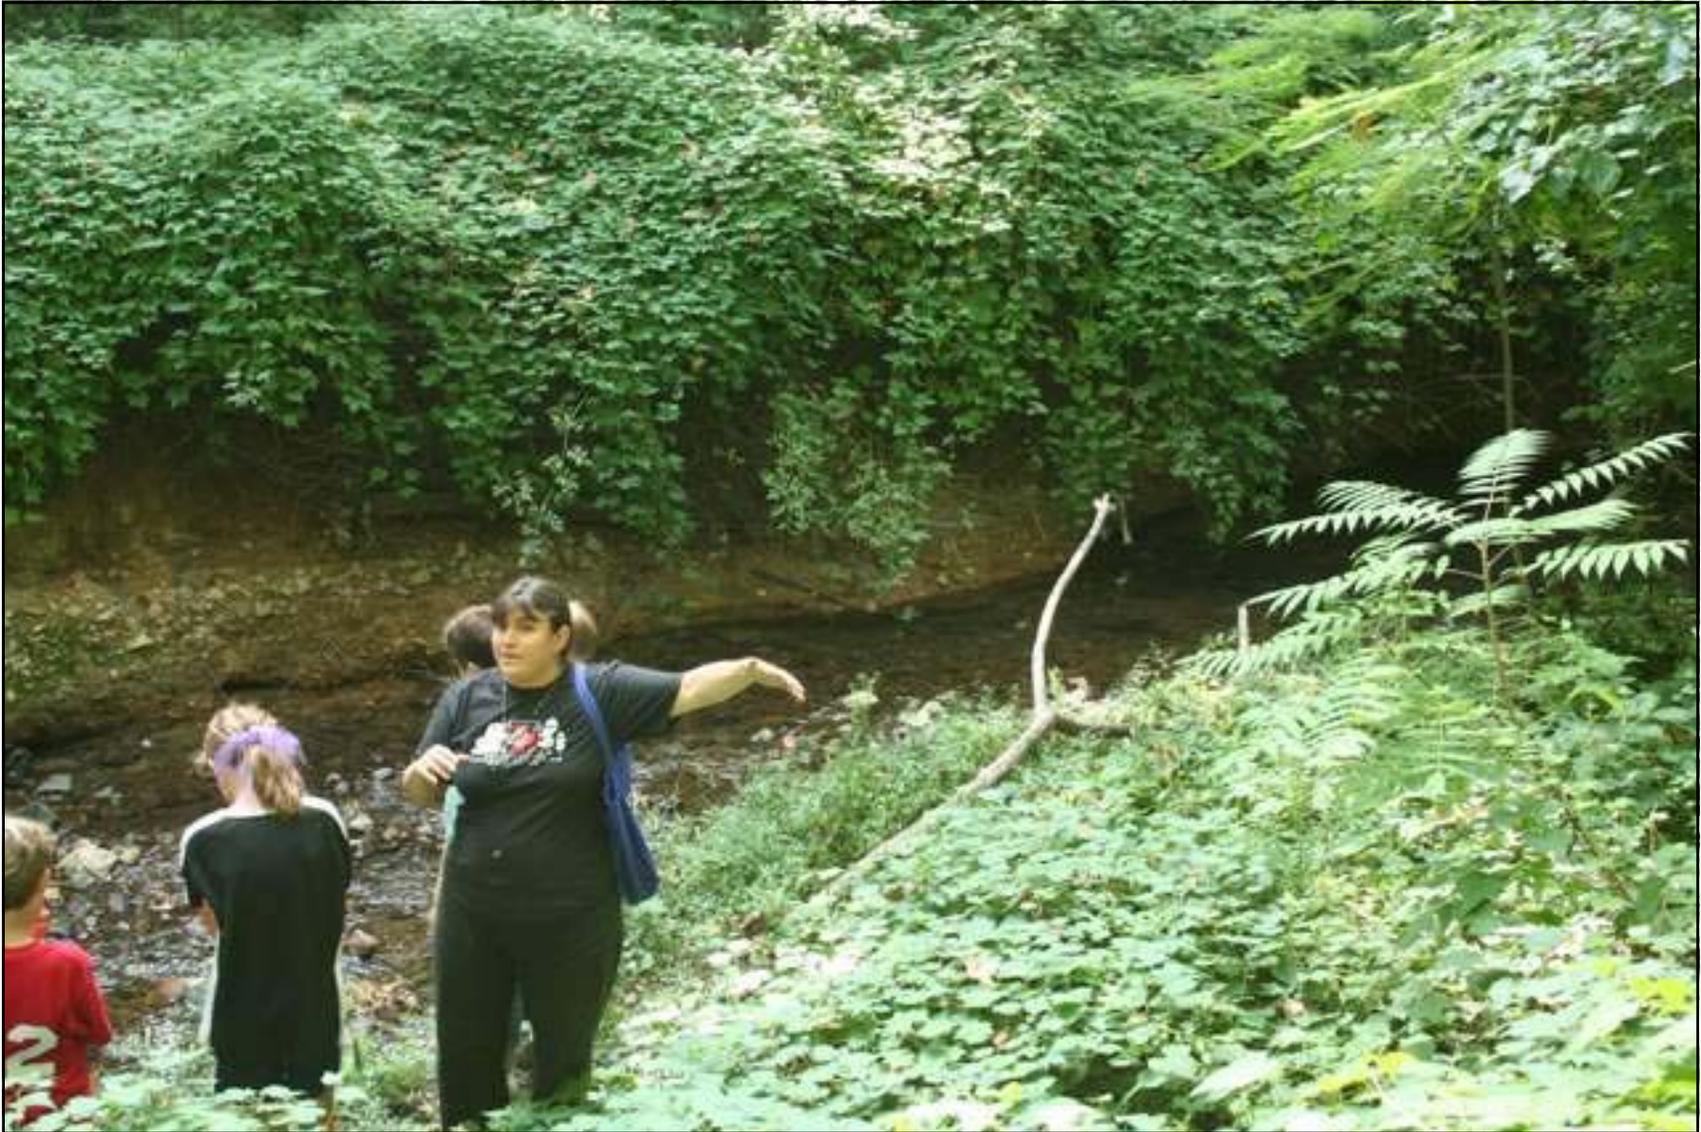
Non-native porcelain berry and honey suckle vines have taken over the bank, crowding out the native understory plants that once held the soil in place and kept the banks from eroding. Volunteers have been working to hand remove the vines and restore the native vegetation.

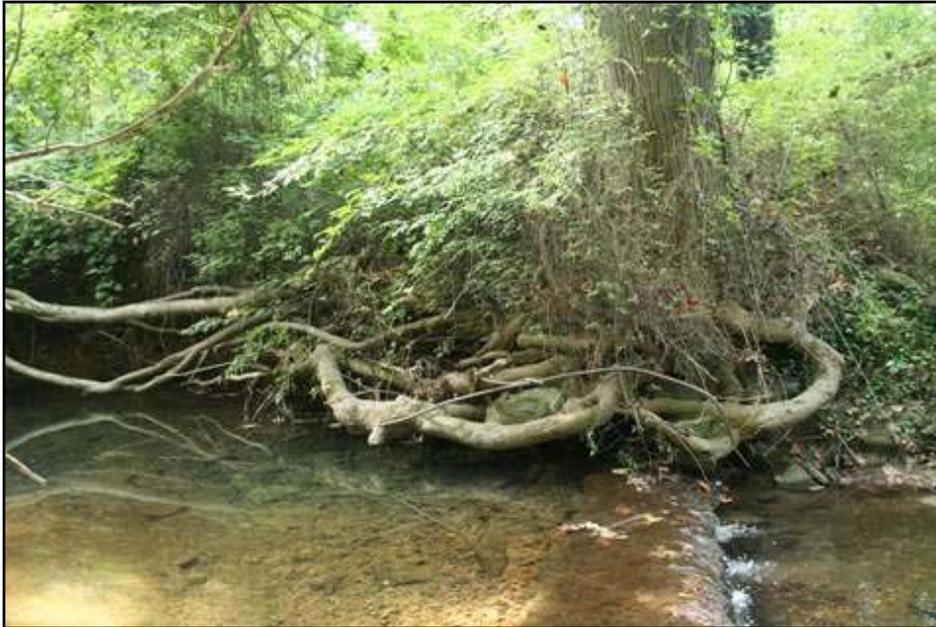
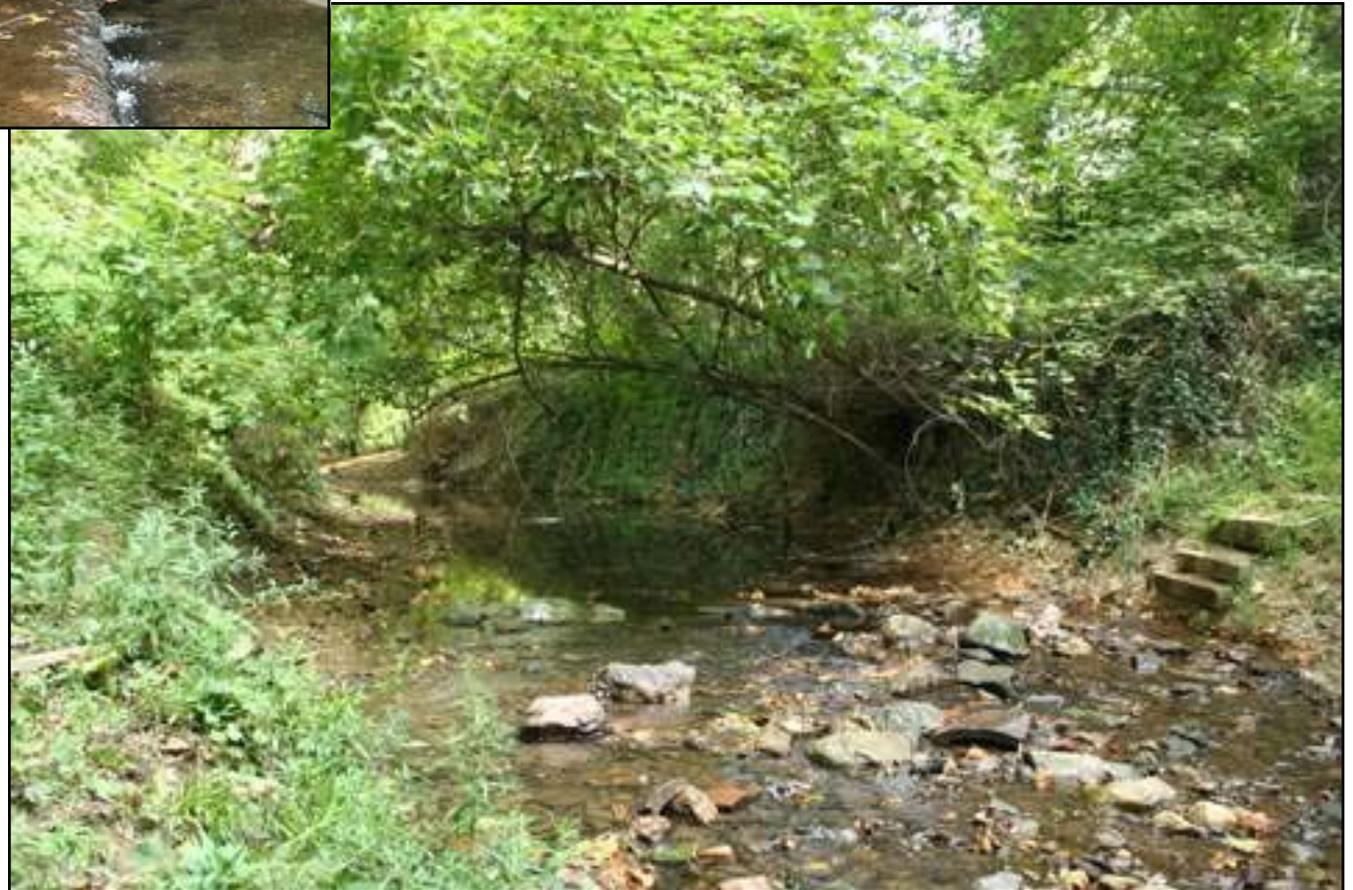
Storm water runoff causes a multitude of problems for the creek. The volume and velocity of water cause severe erosion as well as introducing pollutants. The picture on the left shows tree roots exposed by erosion. This type of undercutting puts the tree at risk of falling. When trees fall, we lose their roots as important bank stabilizers.

On the right, the landing for steps built in 2006 as an Eagle Scout project has already been washed out by erosion. The steps are also in danger of washing out as the volume and velocity of water coming from the Wisconsin Avenue inlet after a storm is too strong for the bank.

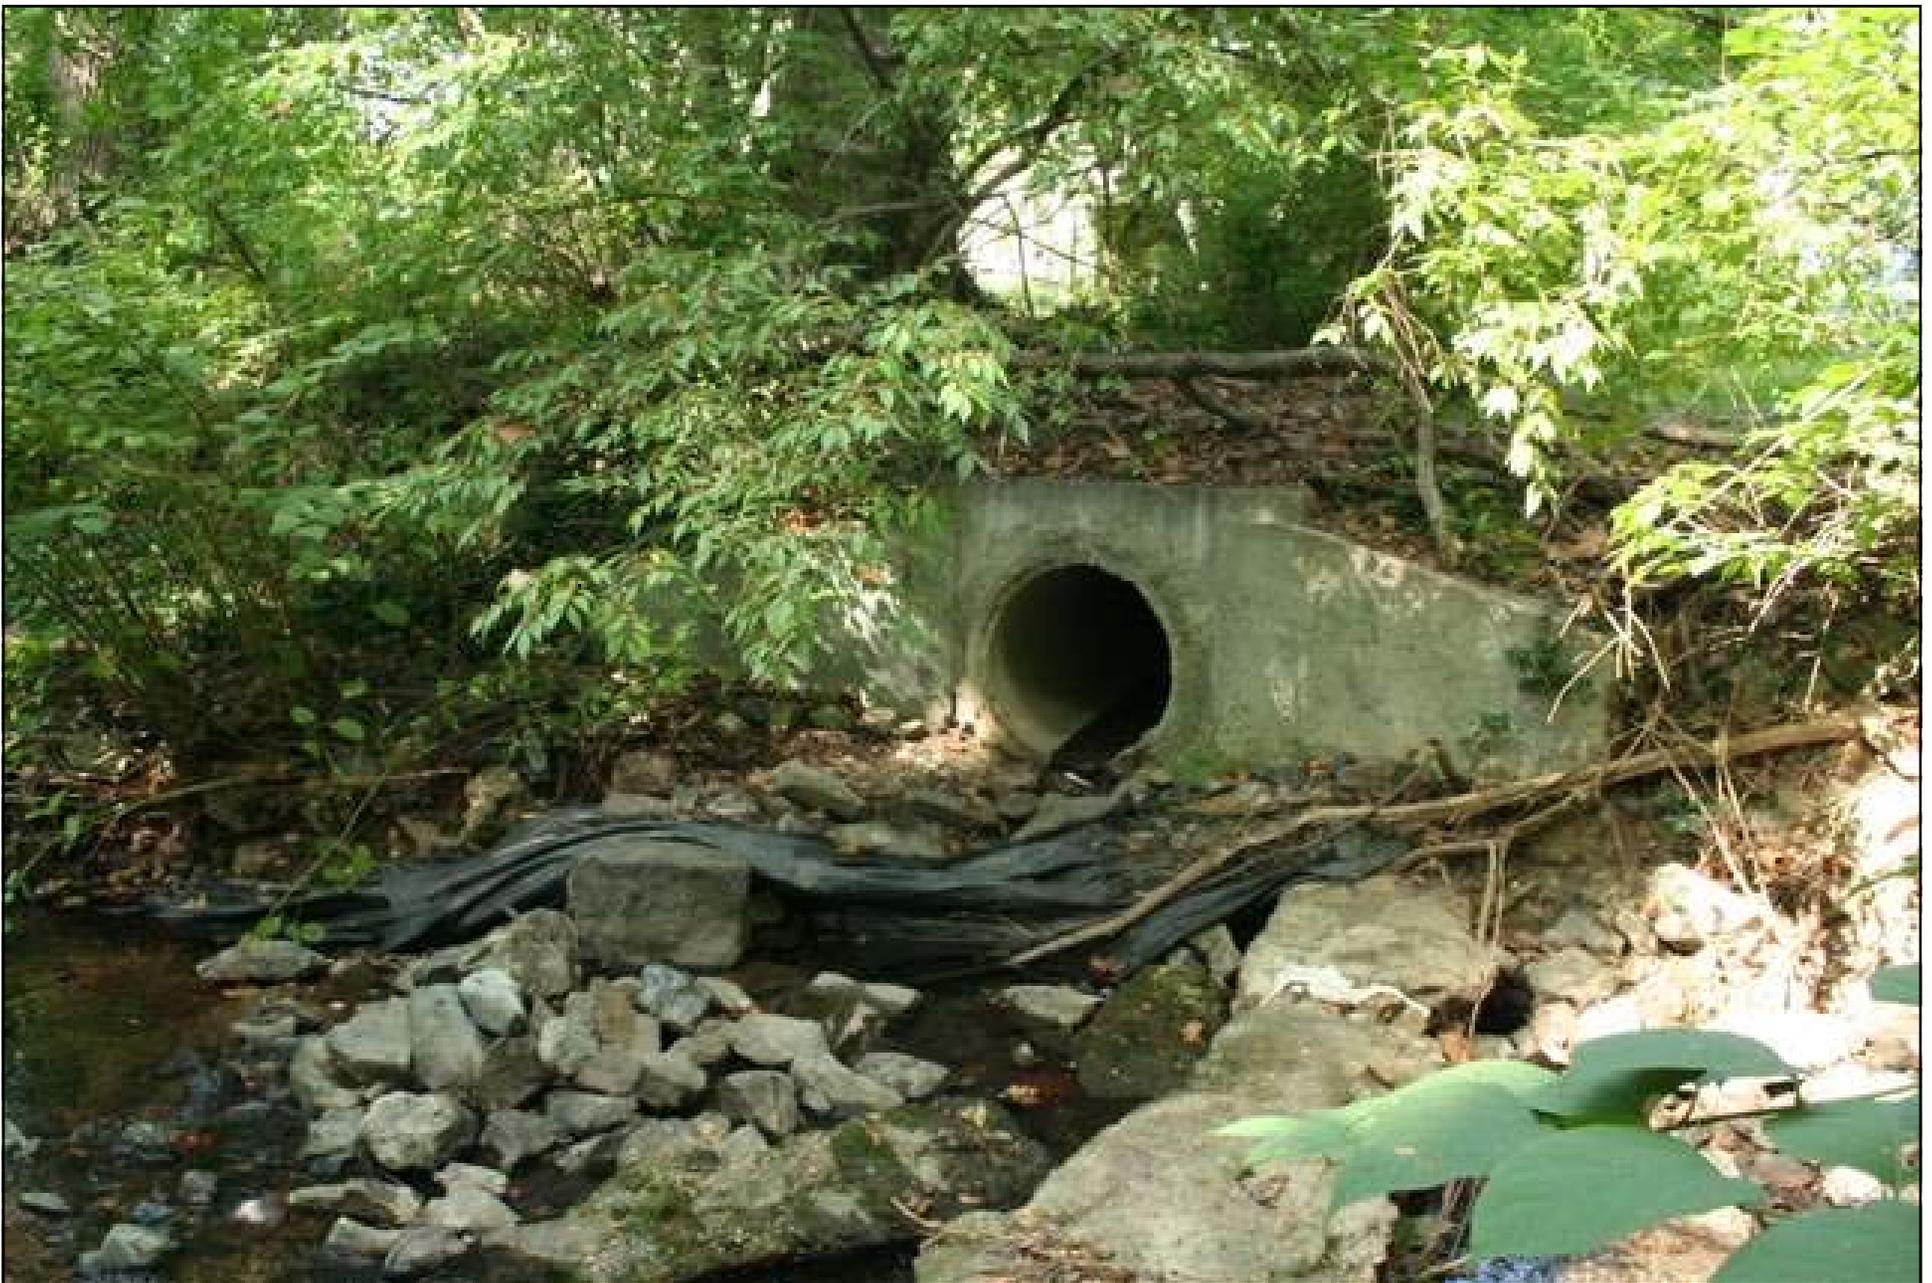
One of the three storm drains inlets from the Town of Somerset. Here you can see remnants of a past erosion control project. The black tarp was laid under rocks to slow the water emerging from the conduit. Unfortunately, the water moved the rocks leaving just the tarp!

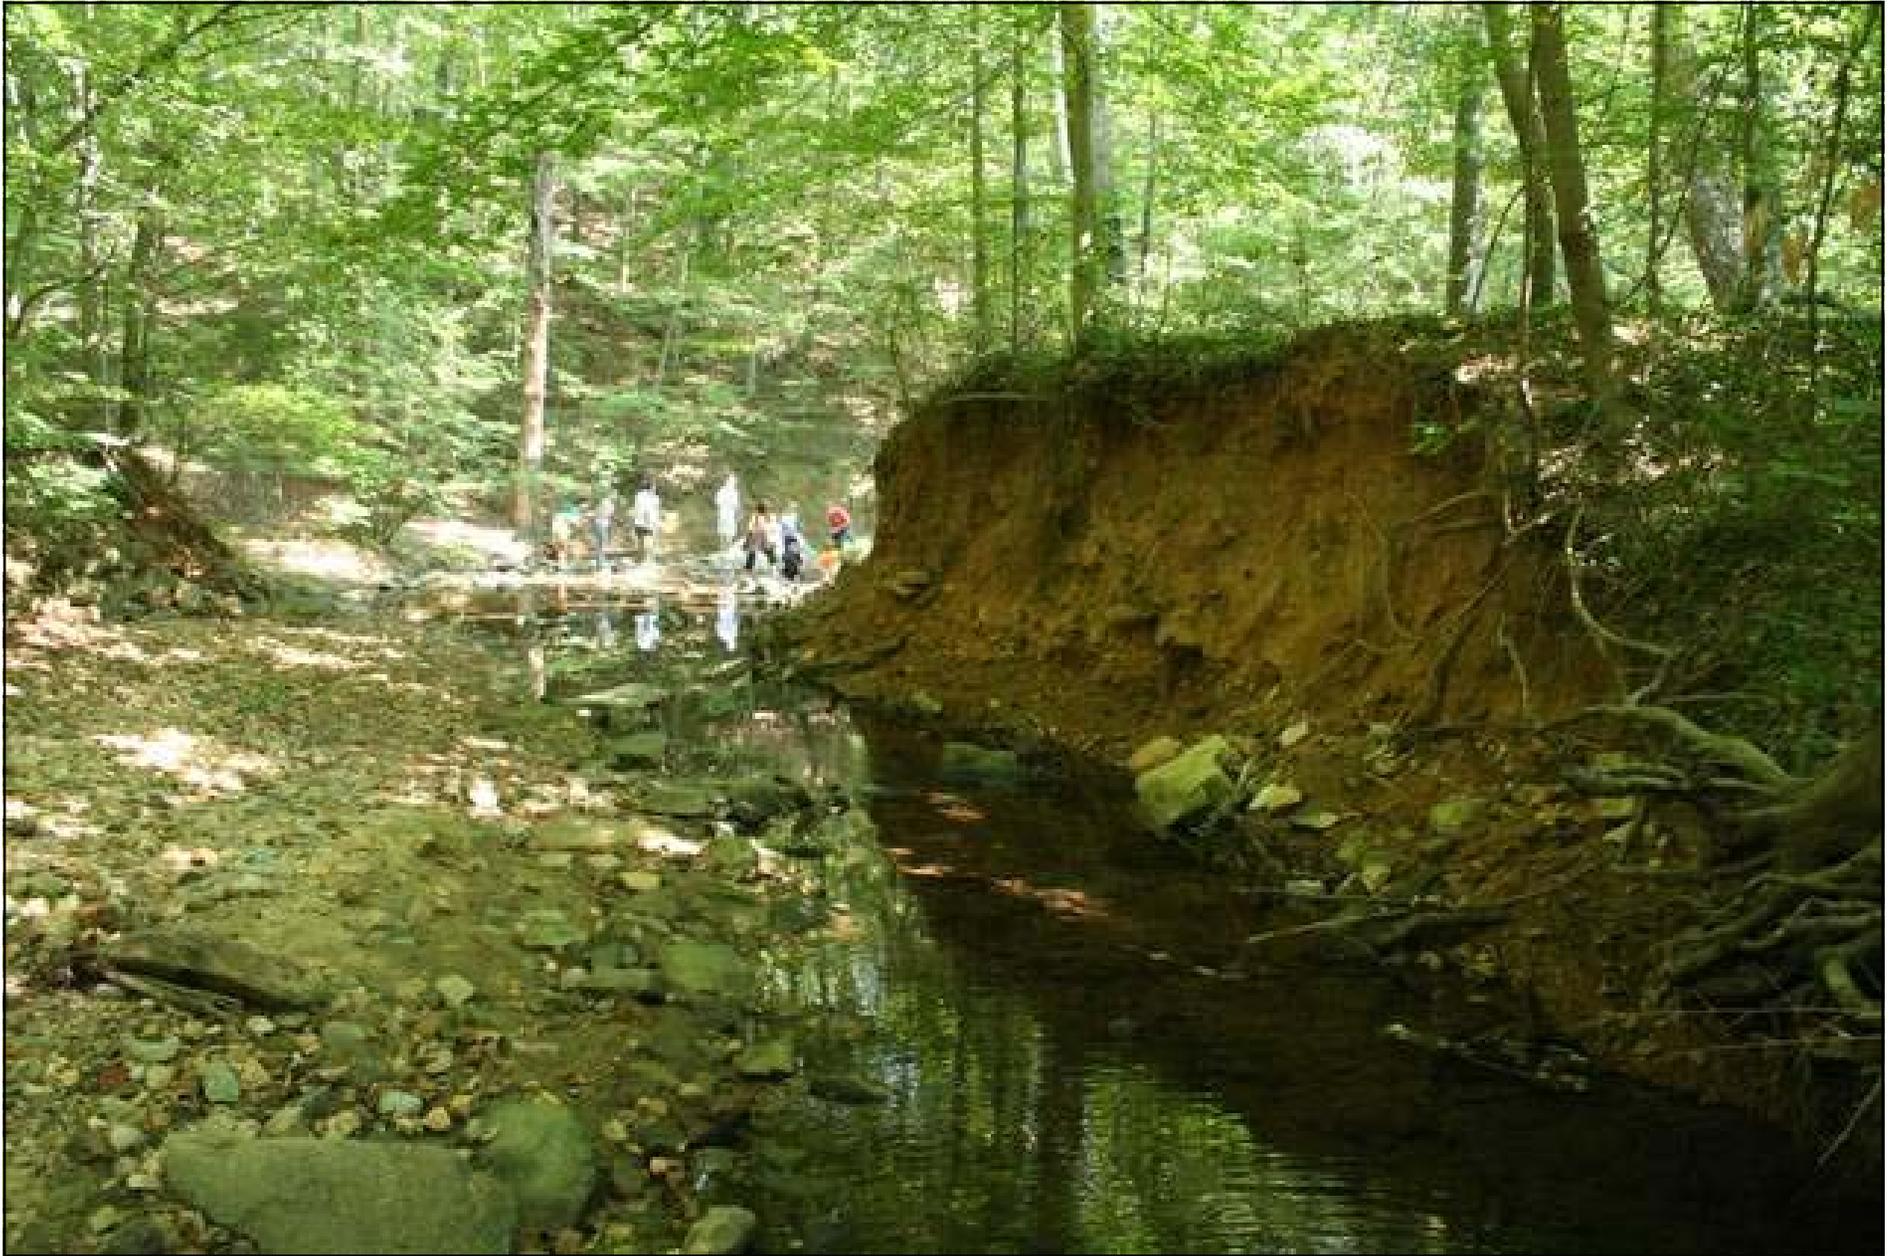
Crossing the Stream on Stepping Stones: On the right bank, you see **scouring** - a typical form of erosion found in urban creeks. This bank was built up in the early 1900s for a trolley bridge. Its erosion has contributed to the heavy silting that threatens habitat of the macro-invertebrates living on the rocks covering the creek bed. When these rocks are buried, the critters lose their homes.

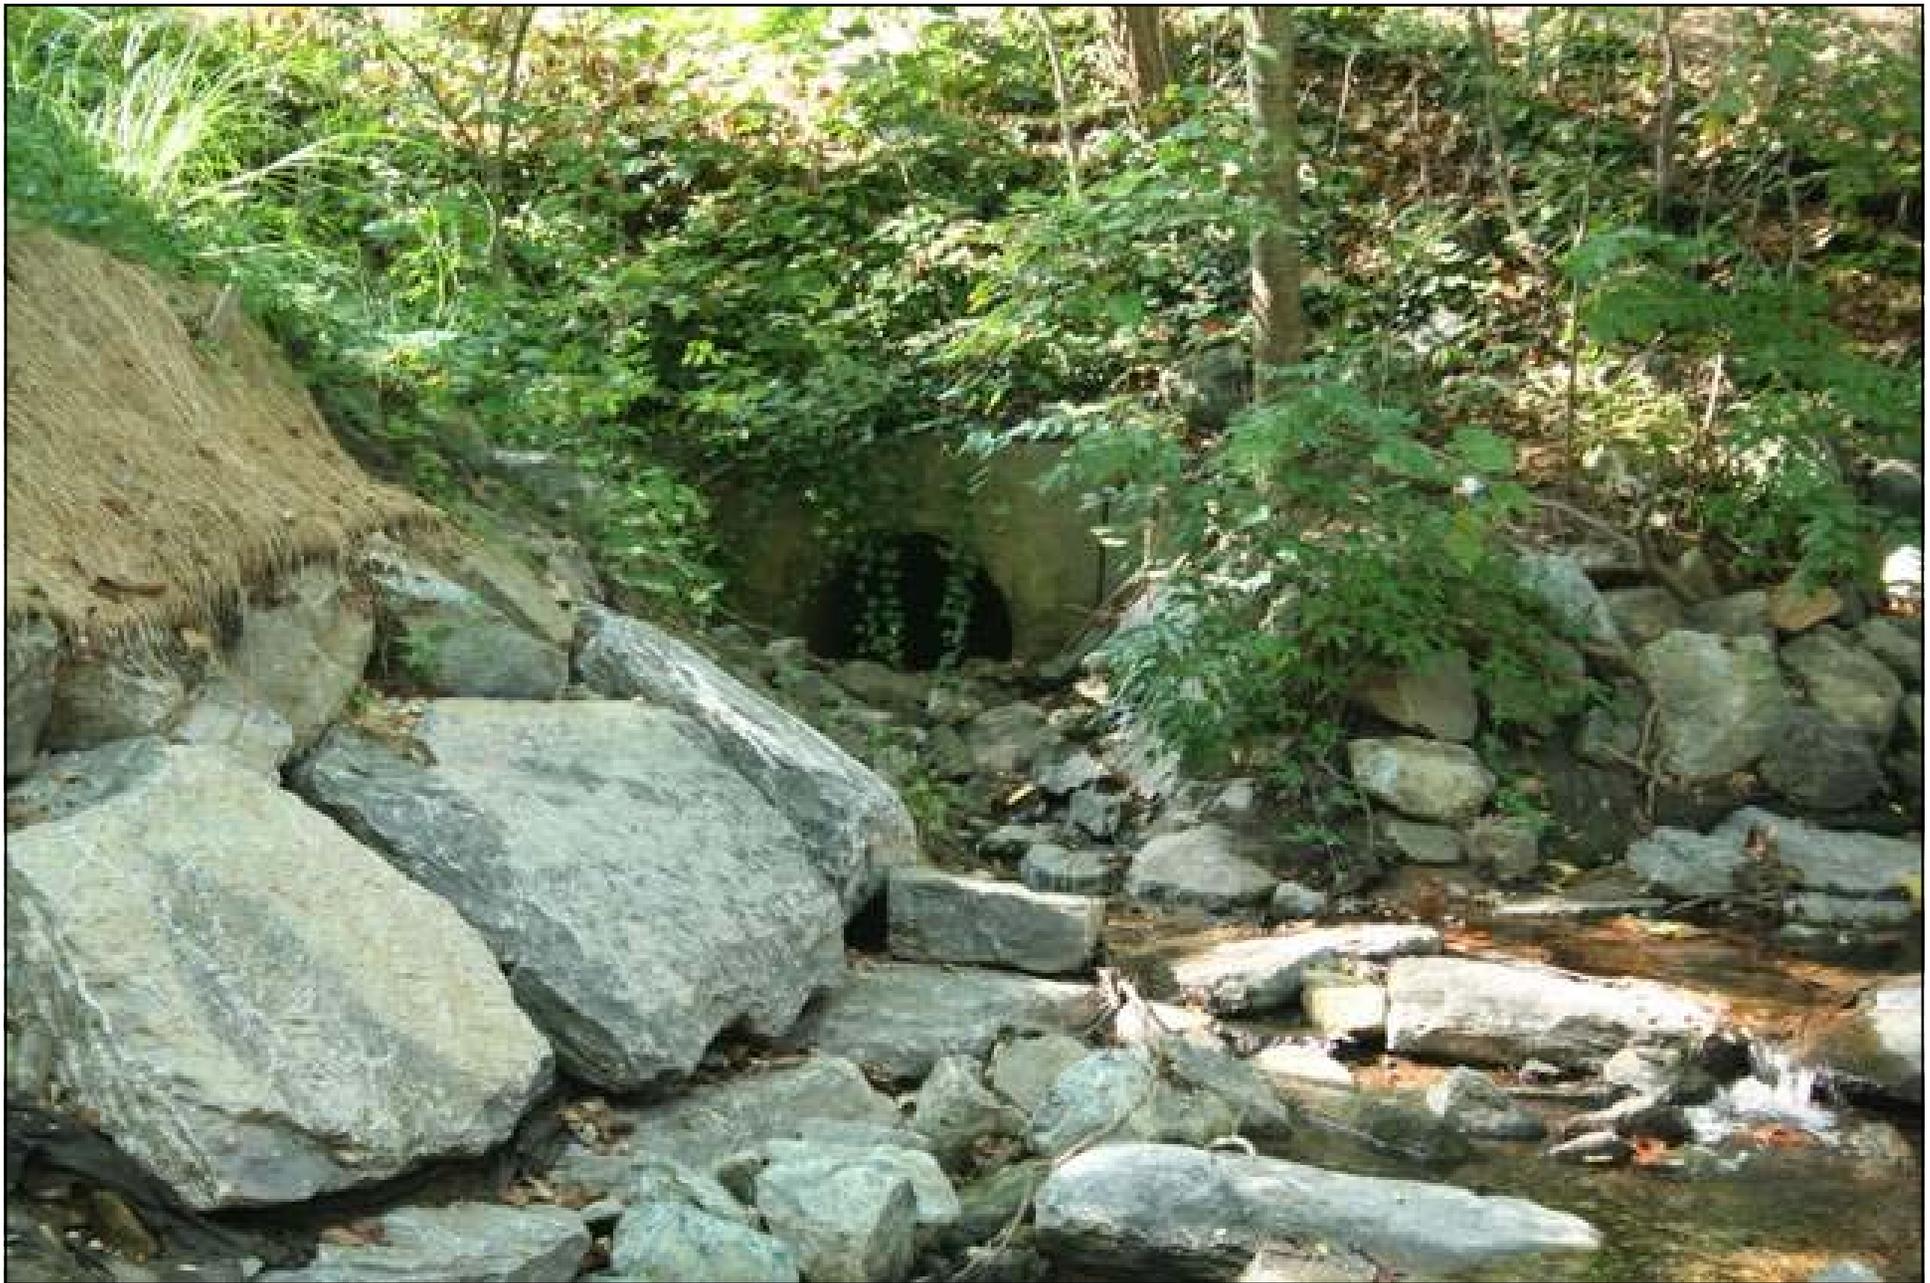
Here we have large rocks and netting to stabilize the stream bank. This replaced the old erosion control method of tarps and riprap. The rocks were first added in 2001. In 2008, another row of rocks was added to the bottom as the creek undercut the first set. You can also see another storm drain inlet. The inlet is being buried and filled in by dirt carried down the storm drain system.

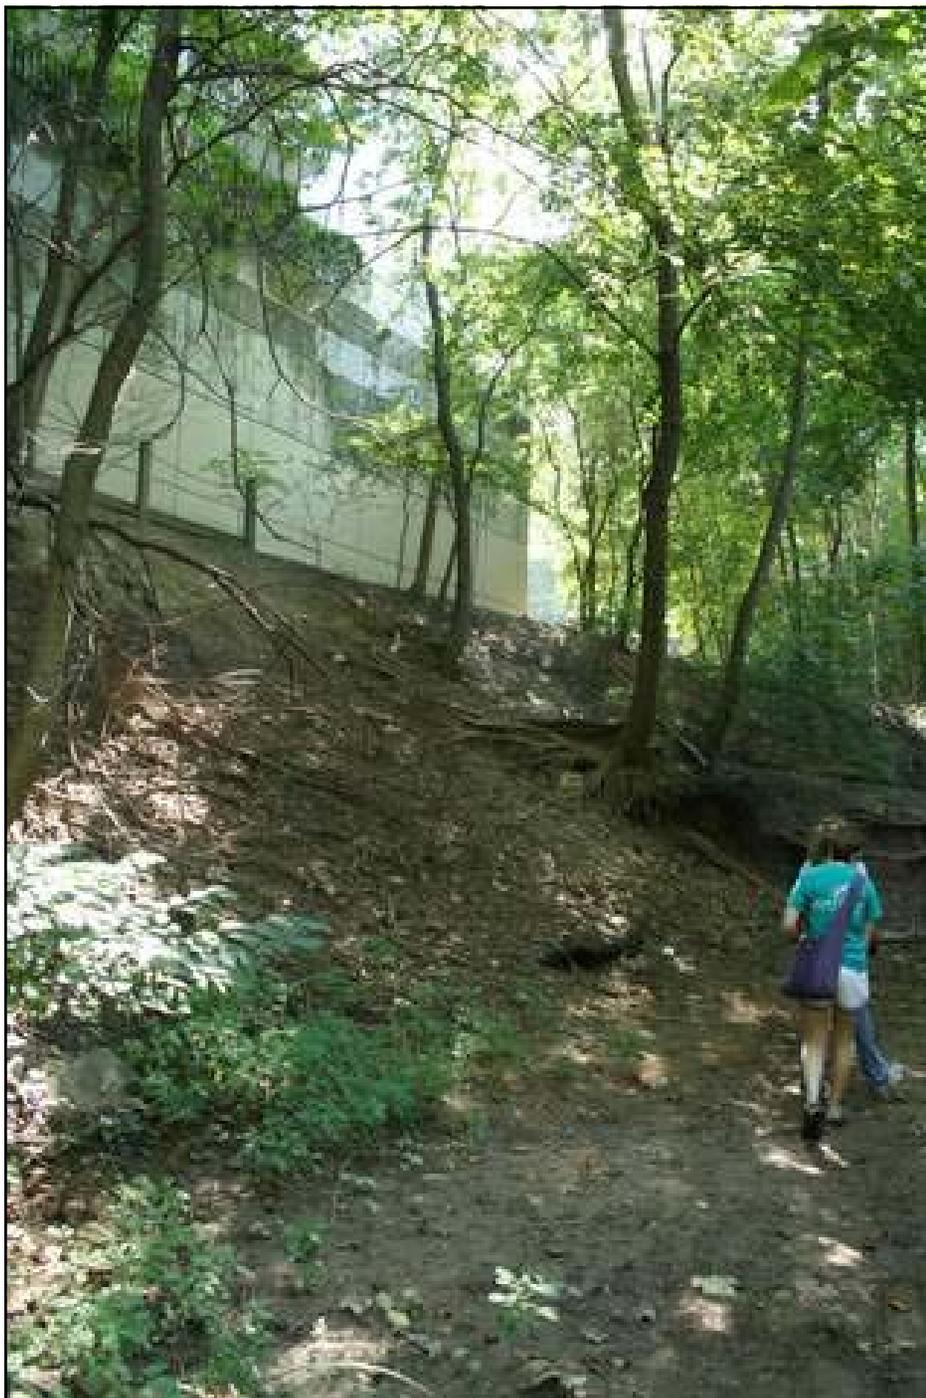
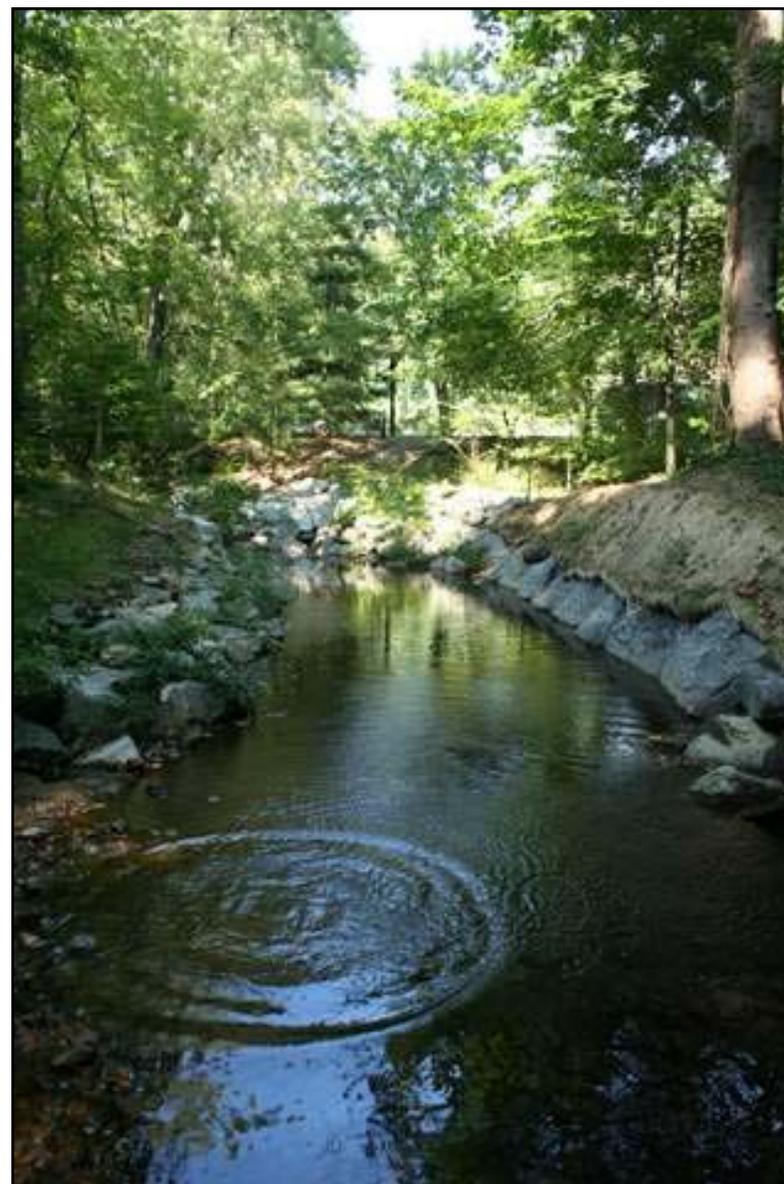
The old stream bed (left) passed too close to the North Park Apartments. A new channel (below) was dug in 2001. Rocks were placed to slow the water during storms.

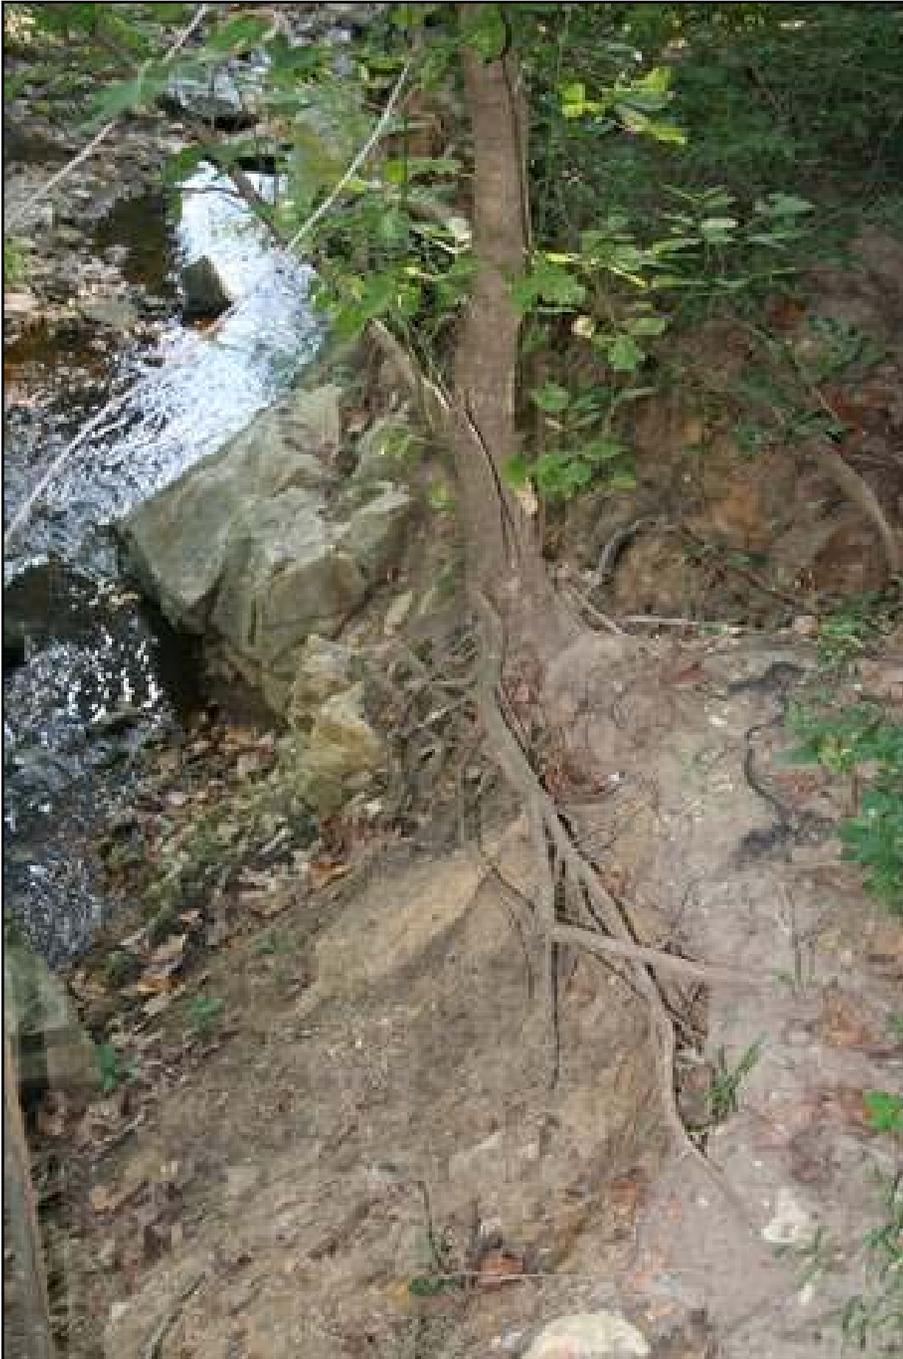
Young tree just holding on. There was soil there when it first put down roots!

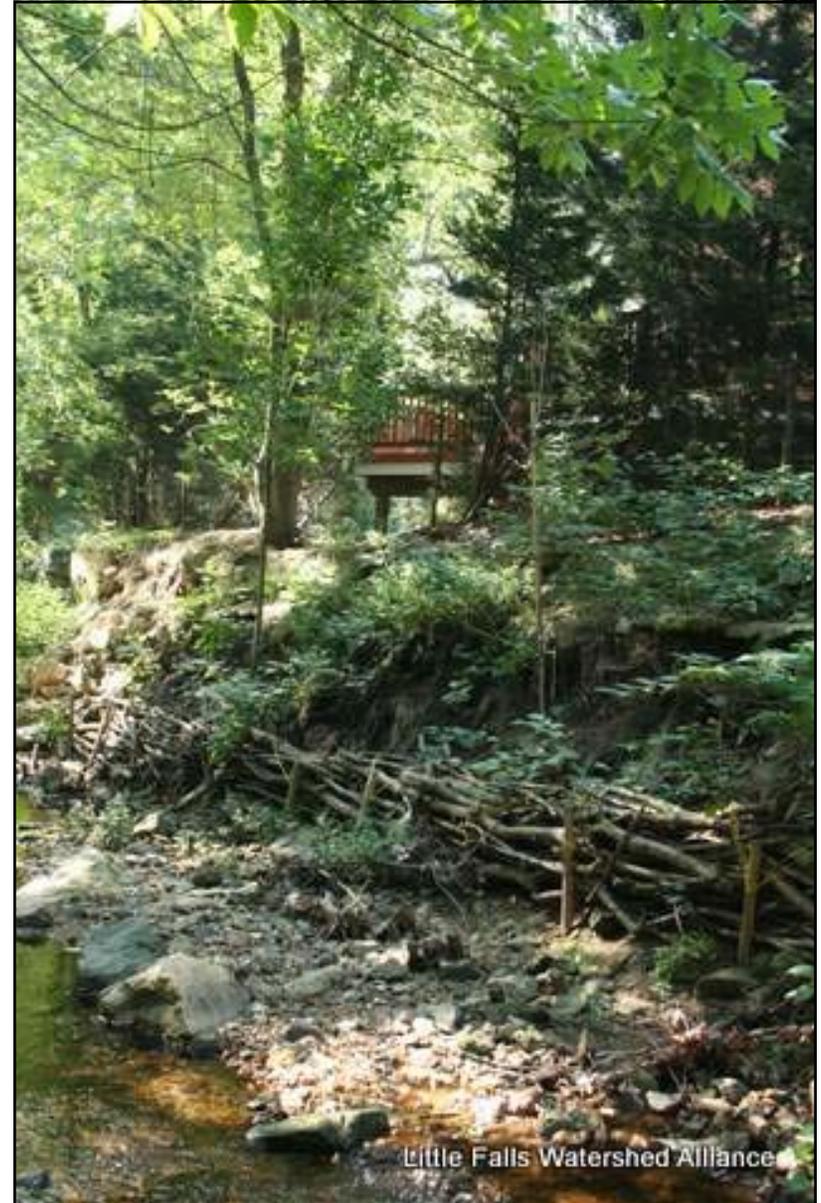
In 2008, bundles of sticks were added to the bank to try to stabilize it to save the property of this house built less than 50 feet from the creek. New regulations discourage building within a stream buffer.
