The Plight of an Urban Stream

A Walk Along Little Falls Branch Creek

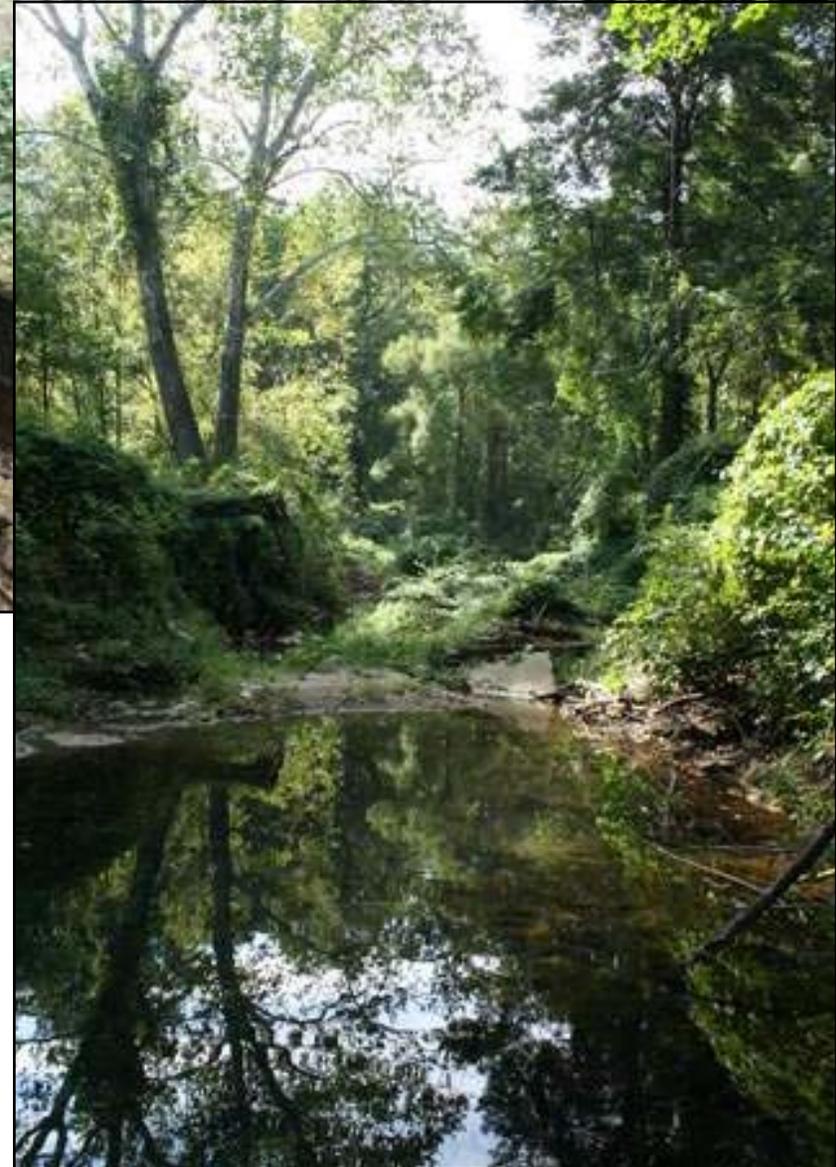
Little Falls Branch at Wisconsin Avenue. The inlet pipe on the right carries ground water pumped from Metro tunnels.

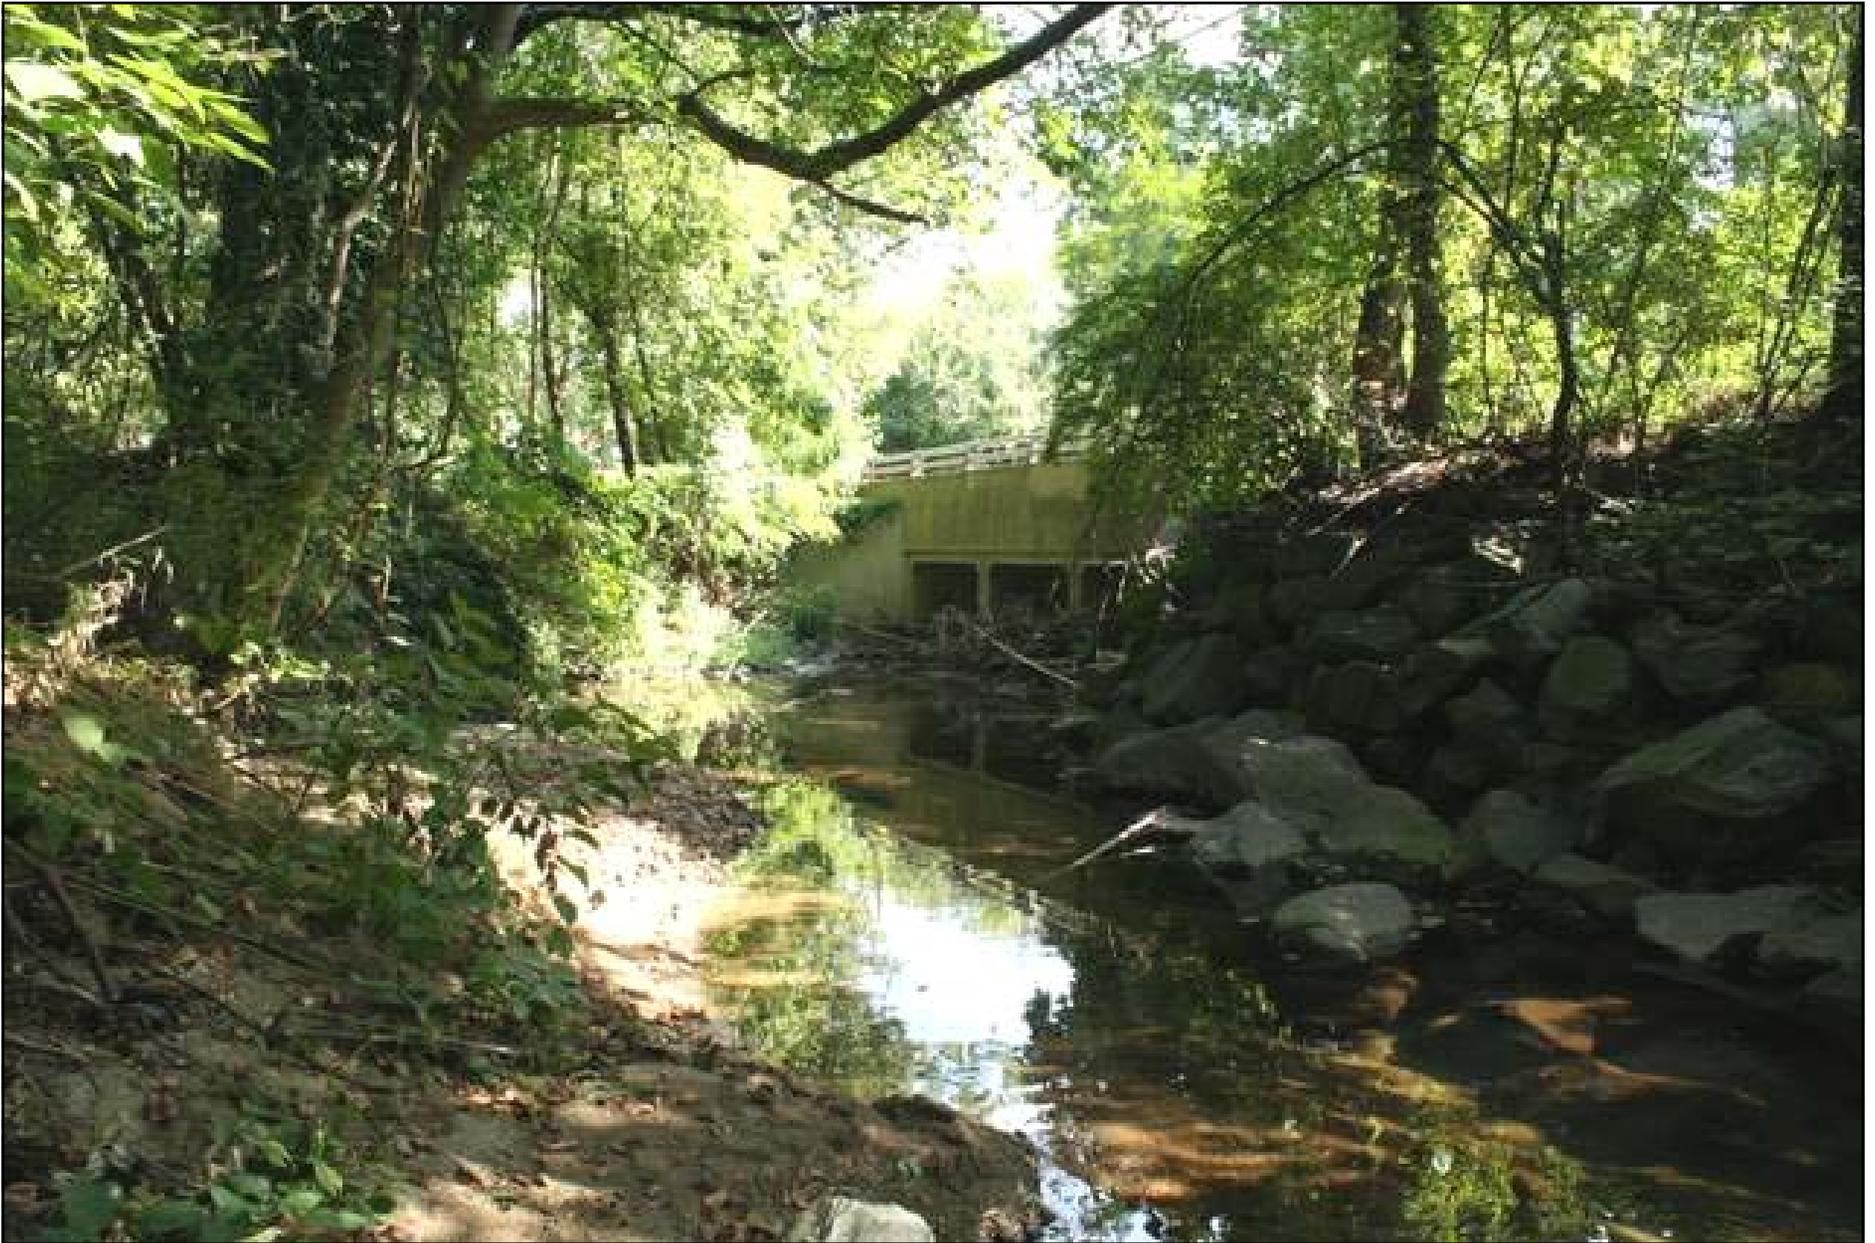
This natural portion of the Little Falls creek ends at River Road. The creek goes under the road and comes out in a channel where it continues to Little Falls Parkway. At Little Falls Parkway, the creek joins with the Willett Branch where it is no longer in a concrete channel. The creek then runs through the Little Falls Stream Valley Park to the Potomac River.
